CHARACTERIZATION OF THE OLD RENDERING MORTAR OF A BRAZILIAN HISTORICAL BUILDING

This paper studies the constitution and properties of lime-based mortars, collected in the *Casa Amarela* (Yellow House), a building of the end of the 19th century, located in Belo Horizonte (Brazil), object of this case study. An experimental study was developed to characterize the rendering mortar of this historic building, aiming to support future interventions/propositions of a recovery mortar compatible in physical, chemical and mechanical terms with the original mortar. The results of the investigation of this material are presented through its microstructural (scanning electron microscopy + energy dispersive spectroscopy and stereoscopic optical microscope), chemical and mineralogical (X-ray fluorescence, X-ray diffraction, scanning electron microscopy, and infrared spectrometry thermogravimetric) characterization. The detected phases were: quartz (SiO_2); calcite (CaCO_3) and microcline (KAlSi_3O_8). With the images obtained with SEM, it was possible to select microregions to target the EDS microanalyzer and perform semiquantitative chemical analysis. The microstructural and mineralogical chara

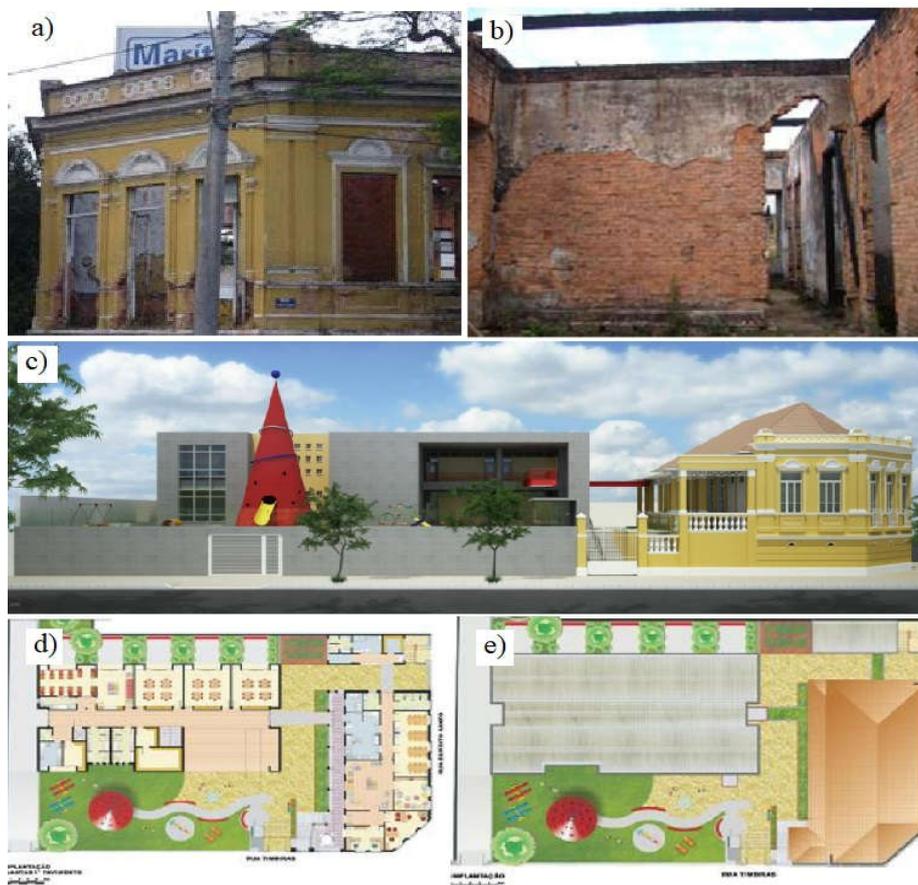
In general, in the studied building, the internal rendering mortars were in poor condition. Most of the mortar of the surfaces was disintegrated, due to its direct exposure to weather conditions. In spite of this, small regions could be perceived with a special treatment in the painting, by the identification of the different pictorial layers and decorative treatment. In the kitchen, the ceramic coating was not complete, it had some broken parts, unsuitable filling with white cement mortar and some dirt, and the same thing happened in the bathroom, where there was a blue ceramic coating, certainly done in recent times. Despite the direct action of the weather, the facades adjacent to the public paths presented the surfaces in a reasonable state of conservation. However, it was observed humidity spots, dirt, missing parts of rendering mortar, structural cracks, superficial cracks, and still detachment of the painting in some regions. The facade facing the internal courtyard did not present the plastering mortar, having the masonry apparent.

It was noticed that the abandonment of the building intensified the problems and due to the characteristics of the mortar, a generalized detachment was generated in all internal and

Figure 1. Casa Amarela (Yellow House) — UMEI Timbiras. View of the facade from Álvares Cabral avenue (a) Facade (b) Internal view (c) Design project of the recovery of the façade (d) Design Project of the 1st floor of the building and (e) Design Project of the 2nd floor of the building. Source: Rede Cidade (2008)

external walls of the edification. As the system is composed of solid brick, the recoating, with a mortar with characteristics similar to the time of construction, was an emergency.

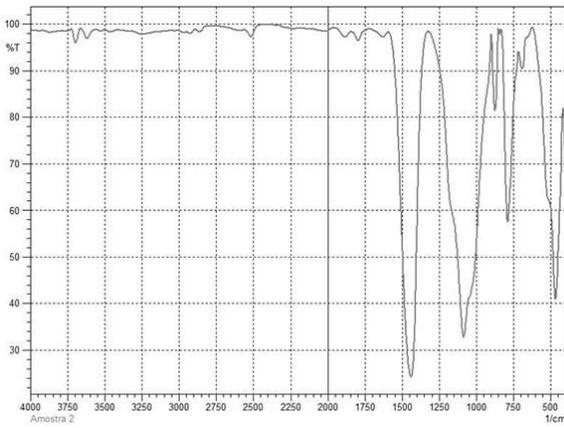
The result is consistent with that observed by Silva et al. (2011) in their samples of old mortar. The authors suggested that the presence of this silicate phase indicates that the aggregate adopted in the mixture originates from a sedimentary source, it means, river sand, while the abundance of calcite is due to the use of lime as a binder. Thus, the calcite is the main responsible for the LOI of the sample; this fact is consistent with the results of XRD and TG. The low MgO content is related to the lime impurity. Iron oxides are associated with the iron minerals present in the sand, as well as other minor and low elements such as TiO₂ and MnO. The other elements, Al₂O₃, K₂O, and Na₂O, besides part of the silica, make up the feldspar microcline. The samples were analyzed by IRS (Figure 5) with Fourier transform infrared spectrometry (FTIR). The results obtained with the infrared spectrum corroborate with what was verified in the XRD, proving the presence of the following phases in the studied mortar: quartz, calcite and traces of kaolinite. In addition, no indicative ranges of organic compounds were detected, emphasizing that IRS is very sensitive to the presence of organic material. Thus, this is a strong evidence of the absence of organic compounds in the mortar sample.

Figure 5. Infrared spectrum - old mortar sample. Transmission method with KBr tablet

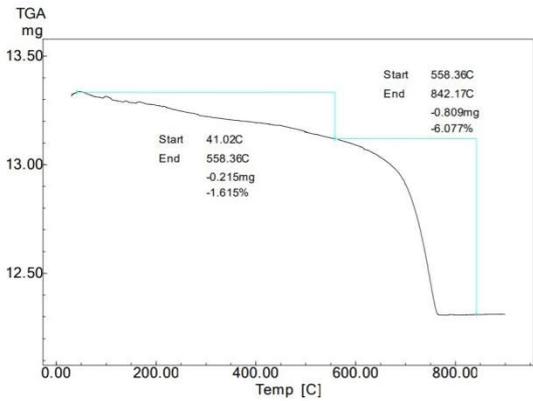
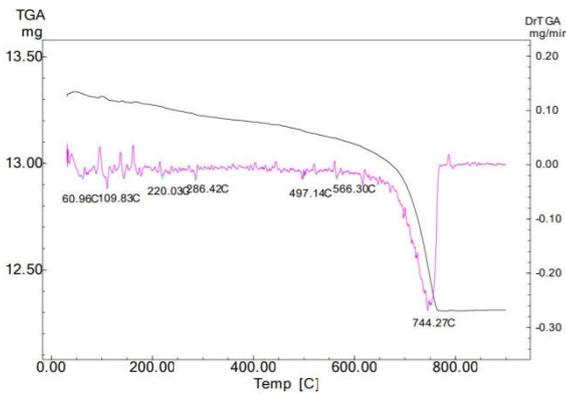
Figure 6. TGA of the samples of mortar, with the losses of mass indicated

Figure 7. Differential Thermogravimetry (DTG) of the samples of mortar

It is a quantitative method, where it is possible to indirectly evaluate the hydrated or carbonated phases developed in the mortar, over time. In Figure 6 and Figure 7 it is verified a total loss of mass of 7.7%, between the ambient temperature and the maximum temperature of 900°C. Such loss can be divided into two parts or regimes:

- A slight loss of 1.6% between ambient temperature and 558 °C, corresponding to the evaporation of moisture and adsorbed water. Similar to that observed by Silva et al. (2011);
- A significant loss of 6.1% between 558 °C and 842 °C, with a loss of mass peak at 744 °C; which corresponds to the decomposition of calcite (CaCO_3), with the emission of CO_2 (pyrolysis). Similar behavior was observed in the studies of Silva et al. (2011) at temperatures above 600°C. In this case, this loss occurred in a temperature

range lower than that of natural calcite, limestones and marbles, which shows this peak at a higher temperature (Brandão, 2010). This is evidence that the calcite present in the sample is not natural, it must be generated by the carbonation of the hydrated lime, which was present in the fresh state of the mortar.

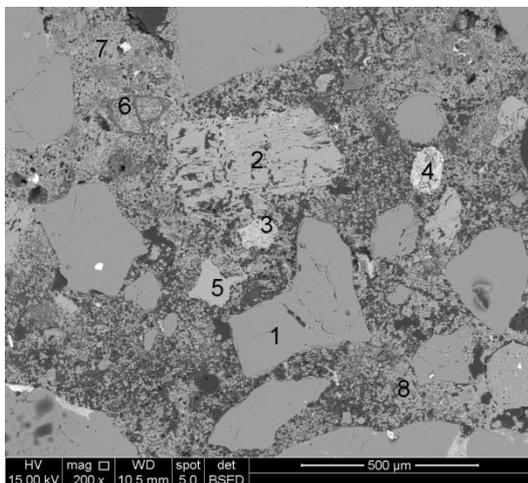
Table 2. Microanalysis referred to the regions marked in Figure 8

Area	SiO ₂	Al ₂ O ₃	Fe ₂ O ₃	MgO	CaO	K ₂ O	Na ₂ O	TiO ₂	CO ₂	Mineral
1	100.0	0.0	0.0	0.0	0.0	0.0	0.0	0.0	N	Quartz
2	49.7	27.8	0.0	0.0	0.0	21.2	1.3	0.0	N	Microcline
3	23.4	24.2	39.2	0.5	9.9	1.7	0.0	1.0	M	Impurity with lime
4	2.8	2.9	24.4	0.0	12.4	0.0	0.0	57.5	M	Impurity with lime
5	0.0	0.0	0.0	0.0	100.0	0.0	0.0	0.0	A	Calcite
6	41.9	25.5	3.0	2.1	19.1	5.4	0.7	0.0	M	Impurity with lime
7	14.5	6.3	0.0	0.0	77.6	1.7	0.0	0.0	A	Calcite, quartz, microcline
8	7.6	5.2	0.0	0.0	86.3	0.0	0.0	0.0	A	Calcite, quartz

Figure 8. General microstructure of the mortar by SEM. Backscattered electron image (BEI) of the polished section

Almost all of the sand particles are composed of quartz, that is, silicose, for example, the region 1 in Figure 8. Microanalysis of the several regions in Figure 8 are shown in Table 2. An intimate mixture of calcite and quartz (Figure 9 and Figure 11) currently forms the thin matrix, responsible for the adhesion of all group. The presence of calcite, restricted to the matrix (absent in the coarse particles) explains the clearer, even locally white, color of the matrix (Figure 2 and Figure 3). In the past, at the time of application of the fresh mortar, this matrix was composed of an intimate mixture of slaked lime (calcium hydroxide) and fine quartz sand, which was responsible for the setting of the material. Over the years, hydrated lime ($\text{Ca}(\text{OH})_2$) has completely transformed into calcite (a phenomenon of carbonation, by reaction with atmospheric CO_2). This conclusion is reinforced by the absence of Portland cement and pozzolanic materials in the mortar. The particle size and crystallites of the matrix is actually very small, ranging from 3 μm to 15 μm (Figure 9 and Figure 11). Figure 9 shows the detailed microstructure of the mortar, focusing on the contact between coarse sand particles and the fine matrix. It consists on an intimate mixture of quartz (fine sand) and calcite (previously lime). Microanalyses of the various regions presented in Figure 9 are shown in Table 3. The region 1 of the matrix (Figure 10) has a higher concentration of calcite (previously lime); region 2 is more typical of the matrix, composed of a mixture of calcite and quartz. Microanalysis of the various regions presented in Figure 10 are shown in Table 4. Not only in the coarse particles, but also in the fine matrix, the degree of heterogeneity is very high (Figure 10) and the presence of mineral impurities is frequent. Figure 9 and Figure 11 illustrate these aspects, evidenced by microanalysis, indicating the occurrence of iron-rich impurities, with rarer phases rich in titanium, fragments of gneiss origin and areas richer in calcium. In its current condition, the mortar was quite friable, with fragments

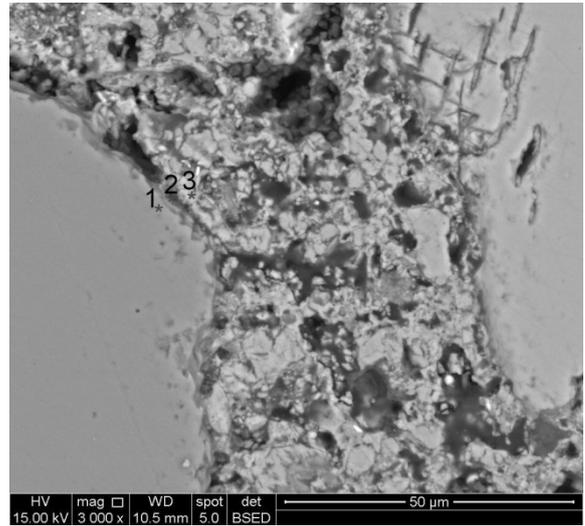
Table 3. Microanalysis referred to the regions marked in Figure 9

Area	SiO ₂	Al ₂ O ₃	Fe ₂ O ₃	MgO	CaO	K ₂ O	Na ₂ O	TiO ₂	CO ₂	Mineral
1	97.9	0.8	0.4	0.0	0.5	0.4	0.0	0.0	N	Quartz
2	47.0	17.1	6.8	0.0	25.9	3.3	0.0	0.0	M	Quartz, microcline, calcite
3	7.5	3.3	1.0	0.0	87.3	1.0	0.0	0.0	A	Calcite, quartz

Figure 9. Detailed microstructure of the mortar by SEM. Backscattered electron image (BEI) of the polished section

Microstructural description: The microanalyses confirmed the identification of the minerals and phases present, already anticipated by XRD, global chemistry, IRS and TGA. In the EDS microanalysis, the carbon element was identified in the spectra, but is not quantified in the standardless analysis. Therefore, this element is correlated in the tables of microanalysis with letters that are estimates of its quantity: A = abundant; M = moderately abundant; L = low; N = null / unidentified. Microstructural and microchemical studies show that the mortar is composed of a coarse sand, with a composition mostly quartzous, it means, it is composed of high silica composed particles. This coarse sand also has a contribution of particles of gneiss origin, which is evidenced by the presence of microcline grains (feldspar) and traces of kaolinization. Iron ore particles were also observed, with hematite, goethite and impurities commonly associated with these minerals as manganese and titanium compounds. A notable aspect in the microstructure is the morphology of the coarse particles, which are highly angular (Figure 8, Figure 9 and Figure 10), while the rounded particles are clearly minority (Figure 9). This is an evidence that sand came from an eluvial deposit and not from an alluvial deposit.

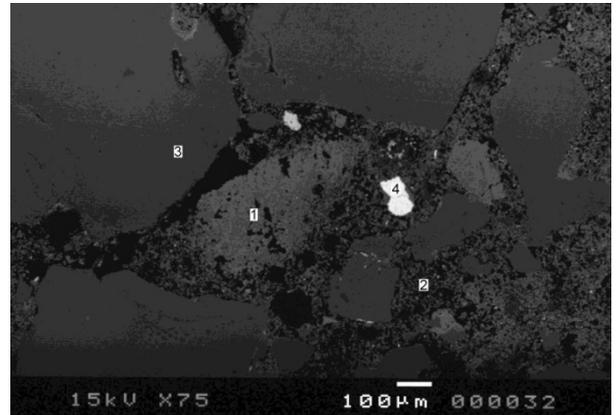
Table 4. Microanalysis referred to the regions marked in Figure 10

Area	SiO ₂	Al ₂ O ₃	Fe ₂ O ₃	MgO	CaO	K ₂ O	Na ₂ O	TiO ₂	CO ₂	Mineral
1	6.3	1.3	0.0	0.0	92.4	0.0	0.0	0.0	A	Calcite, quartz
2	8.8	3.2	1.4	0.7	85.9	0.0	0.0	0.0	M	Calcite, quartz
3	100.0	0.0	0.0	0.0	0.0	0.0	0.0	0.0	N	Quartz
4	0.4	0.0	99.0	0.0	0.6	0.0	0.0	0.0	N	Hematite

Figure 10. Mortar microstructure by SEM showing big particles of coarse quartz sand and the thin matrix. Backscattered electron image (BEI) of the polished section

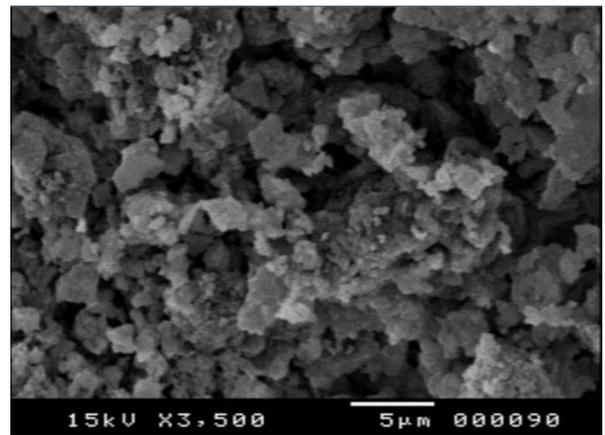
Figure 11. Detailed microstructure of the mortar by SEM, focusing on the thin matrix. Secondary electron image (SEI) of the fracture

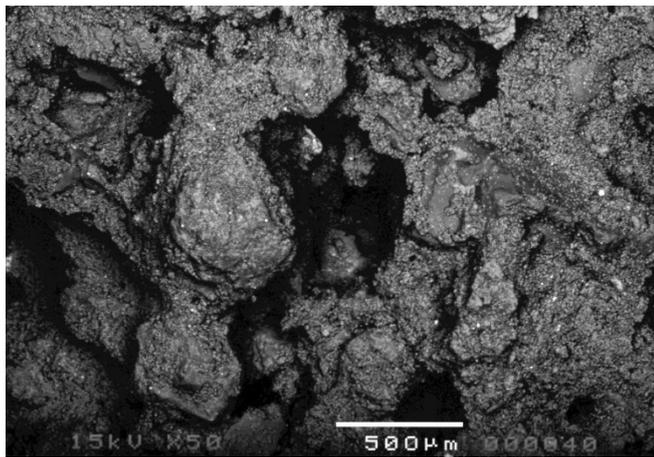
Figure 12. General microstructure of the mortar by SEM. Notably porous area. Secondary electron image (SEI) of the fracture

detaching with little effort and showing porous regions; this is well evidenced in Figure 13. Figure 11 shows the intimate mixture of calcite and quartz, while Figure 12 shows the general microstructure of the mortar, showing coarse particles, generally angular and enveloped by the matrix. This area is notably porous, indicating the friable behavior of the mortar. The chemical and mineralogical compositions of the particles and the matrix are confirmed by the distribution maps of the chemical elements and by the backscattered electron image, as shown in Figure 13. These maps also show that the matrix, which forms the band between the two large particles, is rich in the elements Ca, Si, O and C, confirming that the matrix is composed of a mixture of calcite and quartz. Another interesting conclusion is that the particle on the right is composed of Si, O, Al and K, indicating that it is the mineral microcline, a feldspar of gneiss origin. The particle on the left consists only of quartz (Si and O).

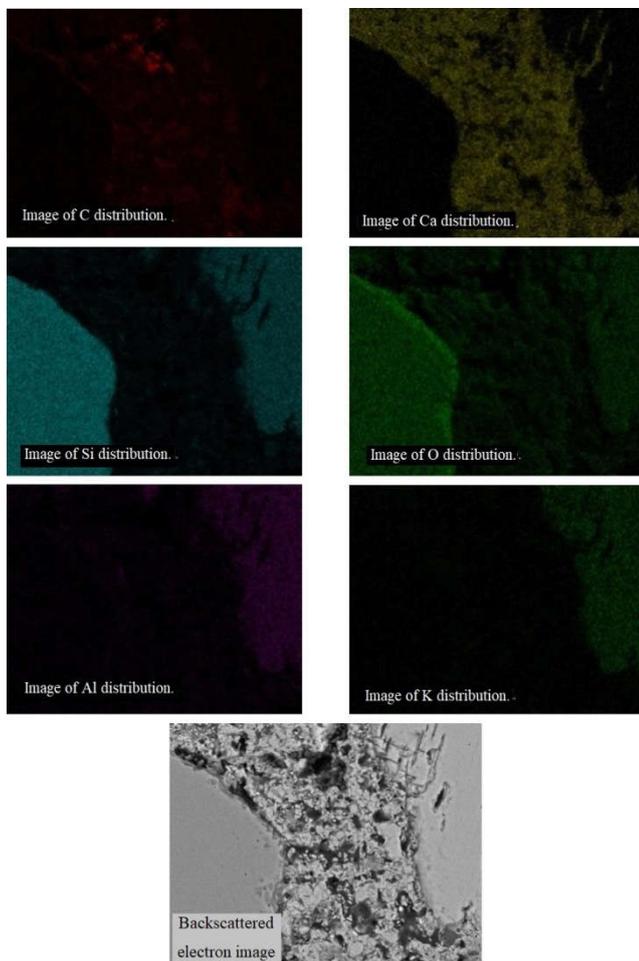
Figure 13. Area mapping of the matrix connecting two large particles (the same area of Figure 9)
