LINKING RELIEF & REHABILITATION WITH DEVELOPMENT AFTER FLASH FLOOD, 2013 IN JOSHIMATH BLOCK, CHAMOLI DISTRICT, UTTARAKHAND

¹Priyanka Tyagi and ²Ravindra K. Pande

ABSTRACT

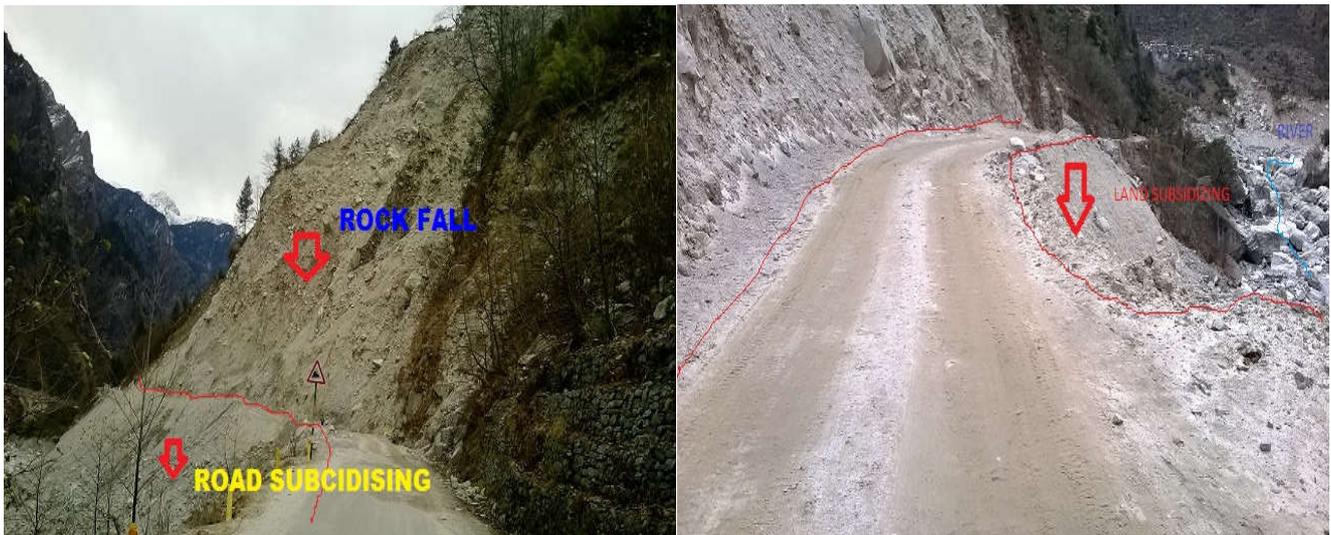
Plate 1. Unplanned road construction towards Badrinath

A seasonal stream is down streaming from Padgasi to Alaknanda River, all water of this stream is collecting on road and due to that, road is in initial stages of initiation of slide.

Road Link To Badrinath: Road links from Joshimath to Badrinath have been reconstructed after flash flood 2013 is one bad example of neglecting LRRD concept. Road is constructed in so hurry that proper management of drainage is fully neglected in area. When you go to Badrinath, on the way, there is a Gram Panchayt named Lambagad (Padagasi and Arodi villages).

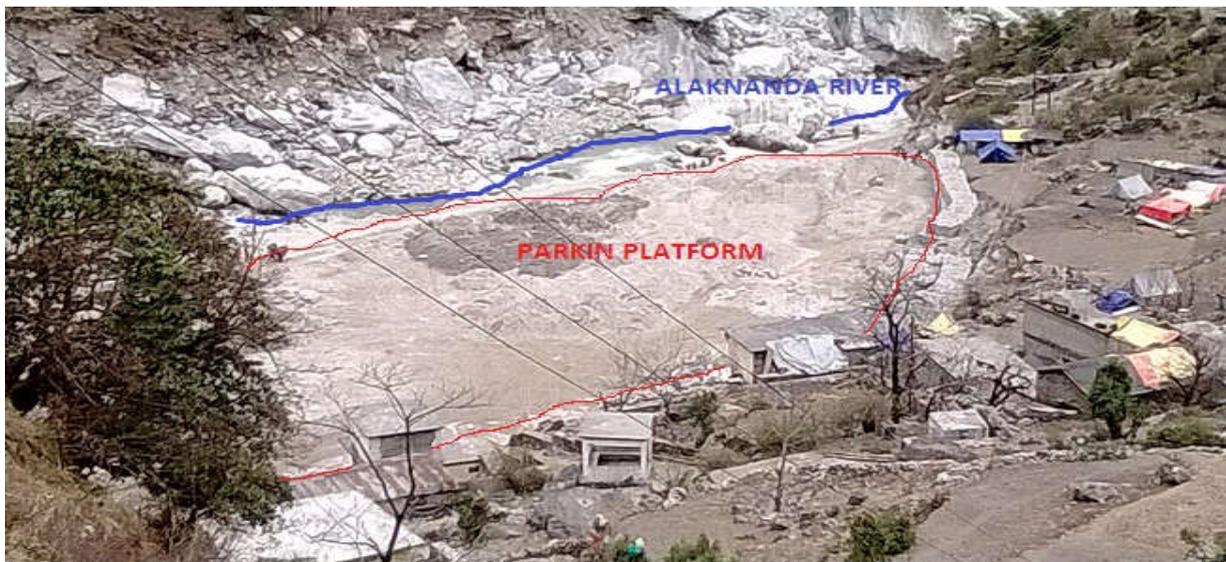
Plate 2. Inappropriate parking construction on the bottom of Arodi village

Parking Place Constructed by JMR Group: A parking platform is constructed by JMR Groups on the bottom of Padgasi & Arodi villages they used silt of river which was accumulated there after flash flood while there is no report of Geological Survey of India is submitted till now, about the geology and its vulnerability. This human-made aggradation on the bottom of both villages increased the vulnerability of area in terms of Geo-physical hazards i.e. landslide (no retaining wall is constructed downward the parking place), Earthquake (It might disturb isostatic balance of land and a triggering factor for earthquake).

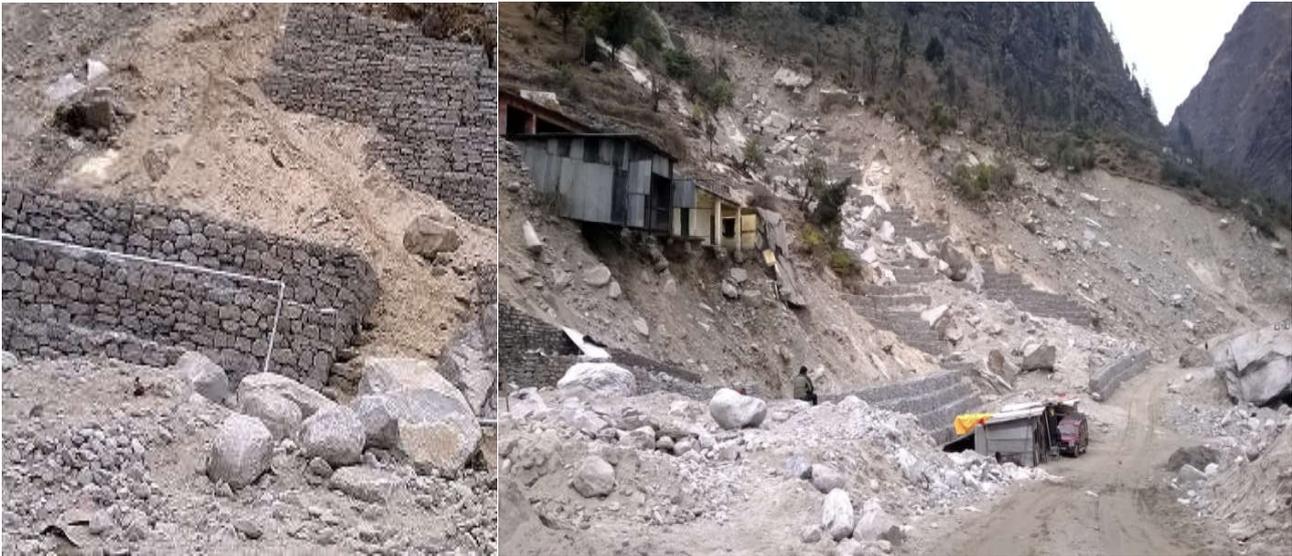
Plate 13. Inappropriate construction of retaining walls on Badrinath road near Lambagad GP

Inappropriate Construction of Retaining Walls: Retaining wall constructed at the bottom of Arodi village does not have proper passage for water flow outside. Water due to its lubricant behavior acts as catalyst for increasing soil creeping and slides in area. These retaining walls are not sustainable for future as they will sustain a little amount of water and will be able to prevent slide only to very small extent but can't bear too much pressure.
