## ACTIVE THERMOGRAPHY AS NON-DESTRUCTIVE TECHNIQUE IN THE DIAGNOSIS OF PATHOLOGICAL MANIFESTATIONS IN WOOD PIECES

Citation: Bremer, C.F., Mello, G. N. A., Maracahipe, A., Krüger, P. G. 2018. "Active thermography as non-destructive technique in the diagnosis of pathological manifestations in wood pieces", *International Journal of Development Research*, 8, (11), 23883-23889.

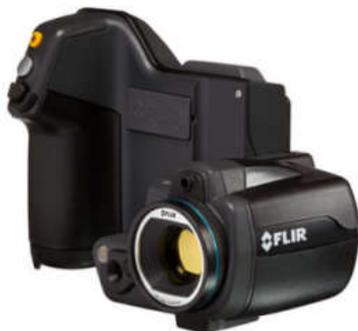
Fig. 2. Infrared camera used in the experiments, FLIR (2016)

The equipment used to capture the thermographic images in the experiments was FLIR camera, T450sc, resolution of 320 X 240 pixels, with IFOV of 1.36 mrad, minimum focus distance of 0,4 m and  $\pm 1^\circ\text{C}$  ( $\pm 1.8^\circ\text{F}$ ) or  $\pm 1\%$  of reading for limited temperature range accuracy, Fig. 2. The wood species used was pinus (pinus elliottii) cut from high quality defect-free boards. For samples cut far from the tree center and small in size in relation to the distance to the pith, the growth ring curvature can be ignored and properties are regarded as orthotropic with three orthogonal planes of material symmetry: longitudinal, radial, and tangential. At structural dimensions and for simplicity in modelling, wood is mostly considered transverse isotropic, assuming identical properties in the radial and tangential directions, Bodig (1982). The pieces were, in average values, 21.2 cm long in the parallel to the fibers direction, 7.2 cm long in the radial direction and 2.8 cm long in the tangential direction. Ambient temperature ranged from  $25^\circ\text{C}$  to  $28^\circ\text{C}$  and 56% relative humidity. The pieces were exposed to heat for 40 minutes, using a halogen lamp, 0.6 m away from the pieces. The camera was used to capture thermal images before, during and after the 40 minutes of heating. While the pieces were still warm, defects were produced on all surfaces, in order to observe the feasibility of the thermography technique as a means of observation for pathological manifestations close to the surfaces of the wood pieces. On the largest lateral faces, 5 nails (15 x 15) were used to produce 1 cm deep holes; on the other two lateral faces 4 nails (15 x 15) were used to produce 1 cm deep holes and at the top and bottom, 2 nails were used to produce 2 cm deep holes, Fig. 3 and Fig. 4.
